**Problem:**

Cracks commonly emanate from the corners of dock pits.

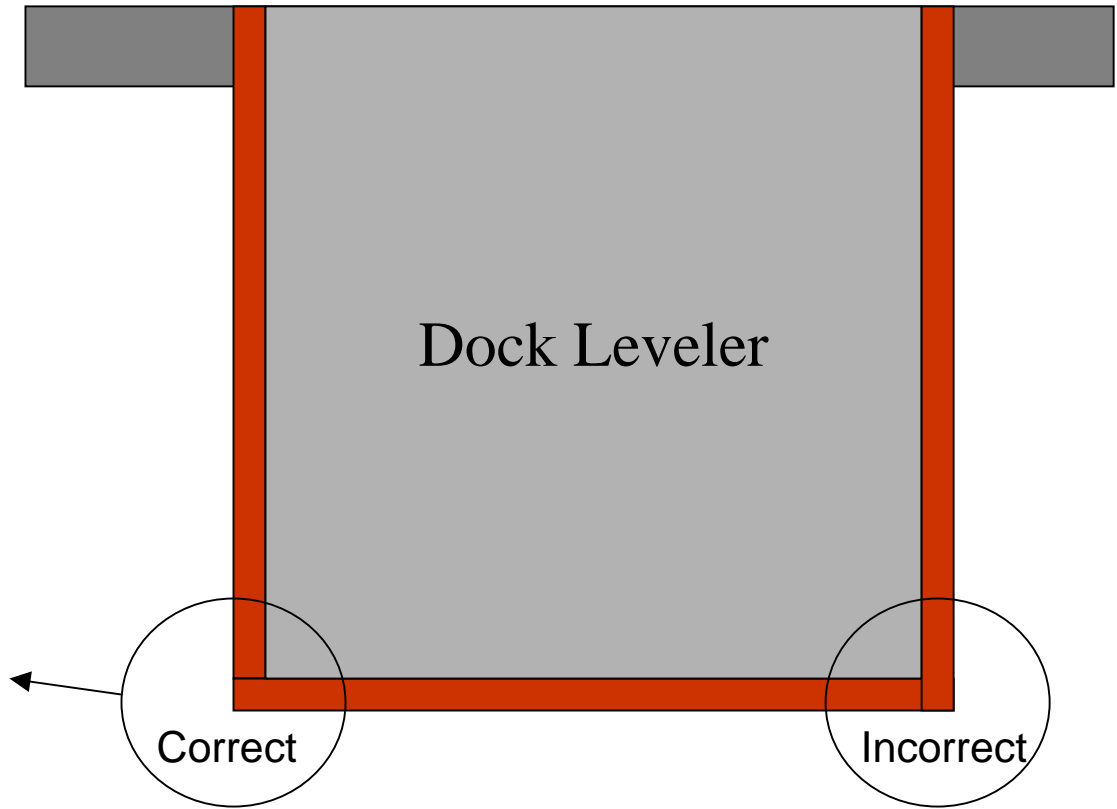
Concrete shrinkage and crack initiation from angles pointing into the floor. (Note: cracks are induced in concrete from all sources of stress).

Provide joints in concrete at dock pit corners (done commonly) and re-configure angles so that the transverse angle is welded to the ends of the longitudinal angles (no protrusion of angles into the direction of the floor).
