Technical Bulletin

Crazing

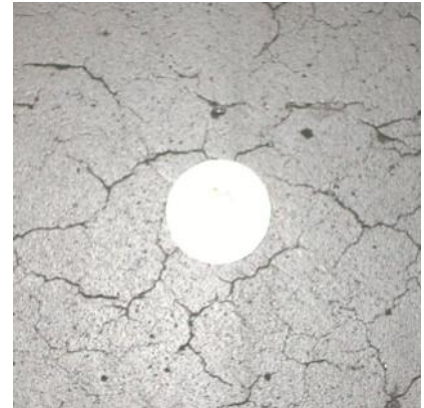
Crazing is common to most interior steel trowel finished concrete floors to some degree. As freshly placed concrete begins to set, excess mix water is displaced upwards through the surface of the concrete known as bleeding. The evaporation of this surface water creates some plastic shrinkage of the cement paste at the surface of the floor. This plastic shrinkage is invisible at the time of slab finishing and becomes exposed to view through surface wear.

Crazing is a non-structural aesthetic concern and has no affect on the performance of a concrete floor.

Plastic shrinkage of the surface paste can be exaggerated when mixes with high water contents are used, in ambient conditions which increase evaporation rates or in slow setting concrete mixes.

Floors which do not incorporate a dry shake aggregate surface hardener exhibit crazing from wear much more quickly than floors which incorporate a dry shake aggregate surface hardener.

There is typically no need to repair surfaces which exhibit crazing.

Concrete mixes should be designed to optimize the water content and incorporate a plasticizing admixture to reinstate any lost workability.

The application of a dry shake aggregate surface hardener is recommended for all interior floors subject to vehicular traffic.
